# COAST DAIRIES LONG-TERM RESOURCE PROTECTION AND USE PLAN

*Existing Conditions Report for the  
Coast Dairies Property*

*June 2001*

*Prepared for  
The Trust for Public Land*

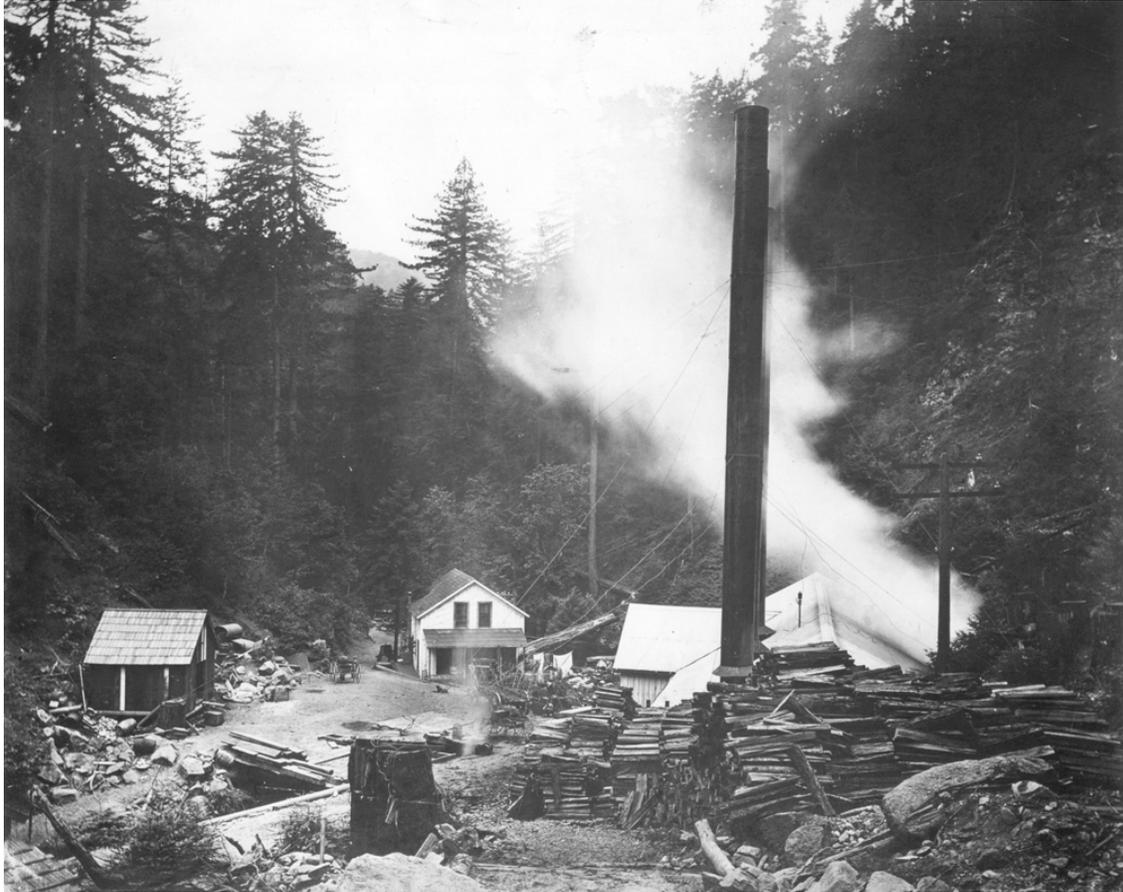
**Photo 1-3:** Big Creek Powerhouse with Steam Generation Equipment ca. Late 1890s

*“The stream known as Big Creek which empties into the ocean about twenty miles up the coast is one of the largest streams in the county and flows through a most picturesque and romantic canyon. It has been a favorite trout stream since American occupation of California, barring the obstruction of three falls, one 90 feet, one of 60 feet and one of 250 feet. Many an angler has questioned the wisdom of placing these obstructions in a good trout stream where distance, declivities and boulders combined to render them inaccessible to sightseers, but this is all solved now for we know that those falls are what has made the Bgt Creek Electric Light and Power Company’s scheme a success.”*(*Surf* 6/10/1896) (see Photo 1-3)

During the first two years, Big Creek power was off as often as it was on. Swanton and his engineers could not have timed their hydroelectric venture at a less opportune moment, as the seasons of 1897-1898 and 1898-1899 saw less than half of the typical rainfall. By the second year of the drought, the flow in Big Creek no longer had sufficient volume to drive the generator and Swanton had to purchase a steam generating plant and install it to supplement the hydroelectric equipment (*Surf* 12/21/1898). Meanwhile, the persistent wind and salt air of the North Coast played havoc with the transmission line into Santa Cruz. In 1900, when he was approached by several investors who wished to purchase the company, Swanton was ready to sell. The new owners refurbished the dams and flumes and re-routed the transmission line by running

it directly over the mountain to Ben Lomond and then down along the San Lorenzo River into Santa Cruz. (*Surf* 2/6/1900). Other improvements were made and the power plant continued to provide electricity through the 1930s. The wildfire in September of 1948 destroyed a considerable part of the flume work and dams, and the last owners (Coast Counties Gas and Electric) did not replace them. The power plant site is still marked on the current USGS quadrangle.

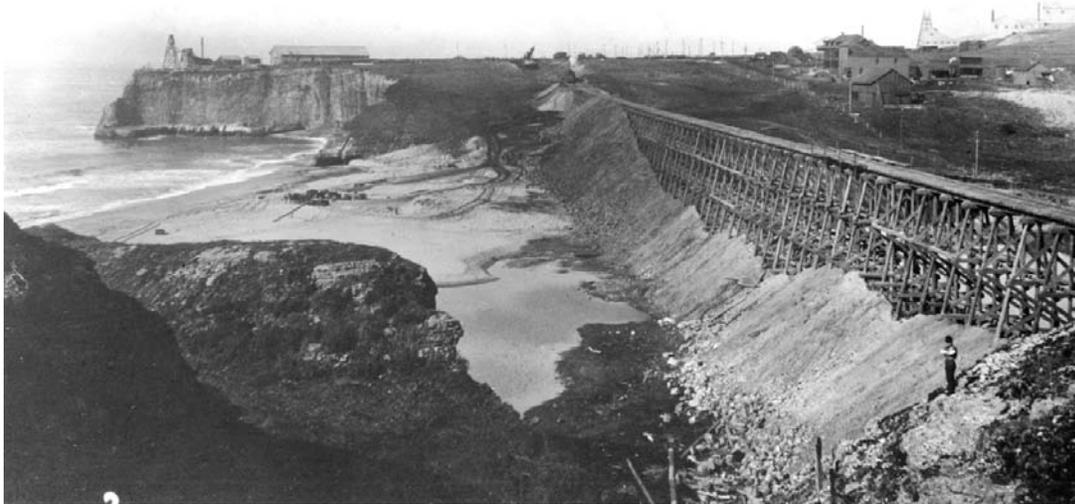
**Photo 1-4:** Filling the Trestle South of Davenport, View to the North to Davenport and the Cement Plant

The plan was to build the trestles across the gullies and lagoons and then fill them in with rock and earth. *“All these trestles except the one just beyond Wilder’s are to be filled and must be filled before heavy trains can pass over them. This work is on joint account between the two companies, and the embankments, when complete will be 36 feet wide at the top, capable of accommodating three tracks.”* (Surf 2/3/1906) Material taken from the cuts was loaded into special side-dumping gondolas and then dumped off the top of the trestles. The result was a string of huge earth-and-rock ramparts each one containing a reinforcing wooden structure as its heart (see Photo 1-4 and Photos 14, 15, and 16 in Appendix 1.3 for a depiction of the sequence of trestle filling).

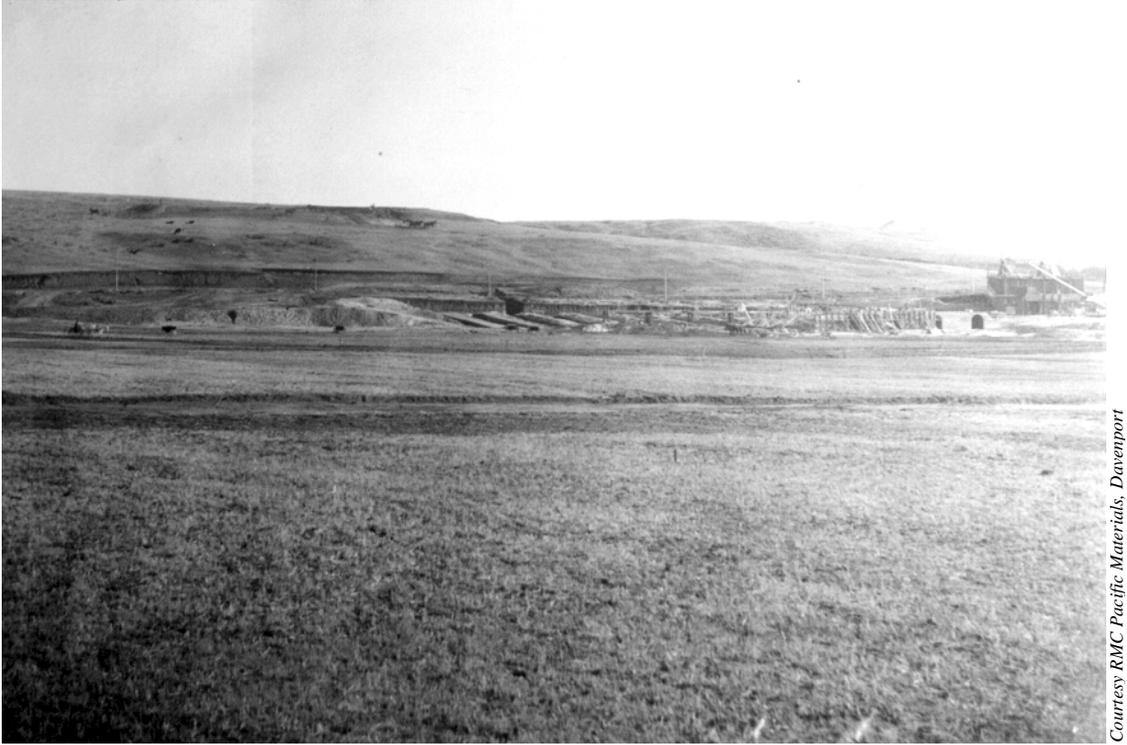
**Photo 1-5:** Construction of the Santa Cruz Portland Cement Plant, View to the East, 1905

Meanwhile, as the Ocean Shore was building its railroad to the San Vicente, the cement plant was rising on the treeless terrace. Using horses and an army of laborers, the San Francisco construction company of Healy and Tibbits leveled the site. The camp for the construction company was in the valley of the San Vicente upstream from the proposed Ocean Shore Railroad grade. Hauling granite from the creekbed and sand from the beach, the company made cement to build the factory. During a visit in February of 1906 Taylor described the rising cement factory “*a scene of extended walls, open arches and massive battlements [that] reminded one of pictures of ancient ruined cities.*” (*Surf* 2/3/1906)

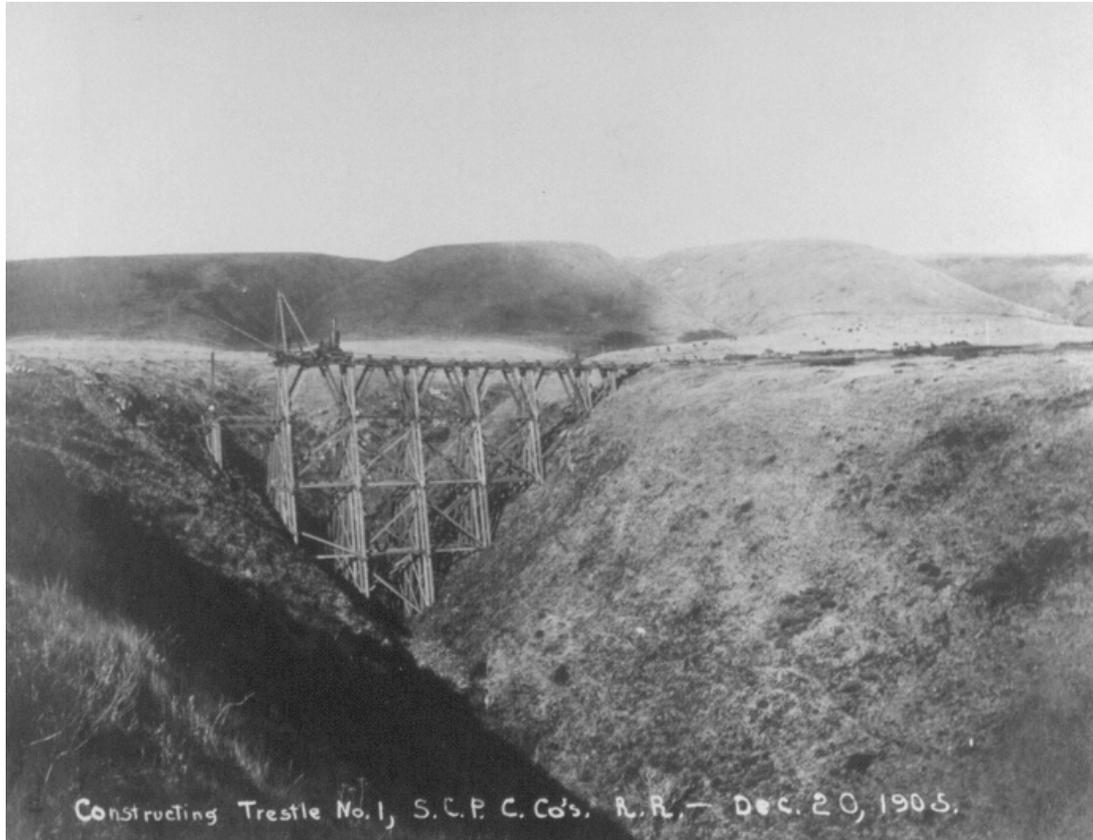
**Photo 1-6:** Construction of the Santa Cruz Portland Cement Company's Trestle No. 1, 1905

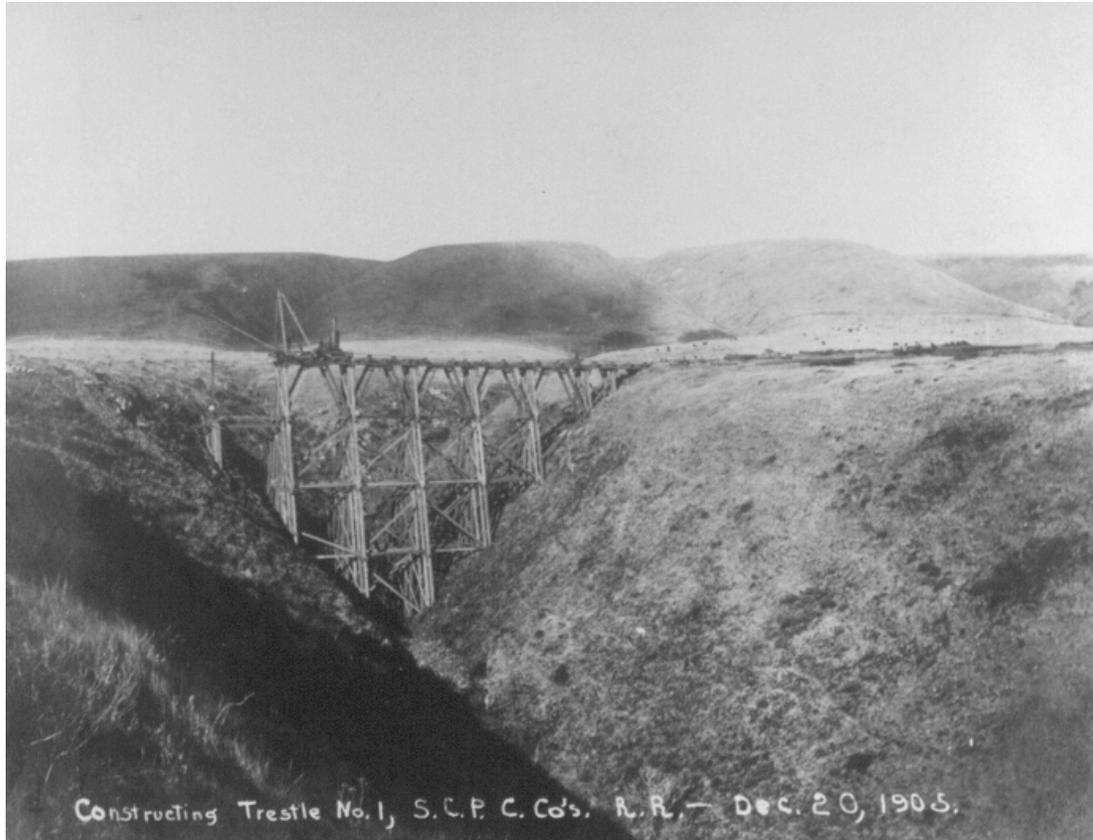
**Photo 1-6:** Construction of the Santa Cruz Portland Cement Company's Trestle No. 1, 1905

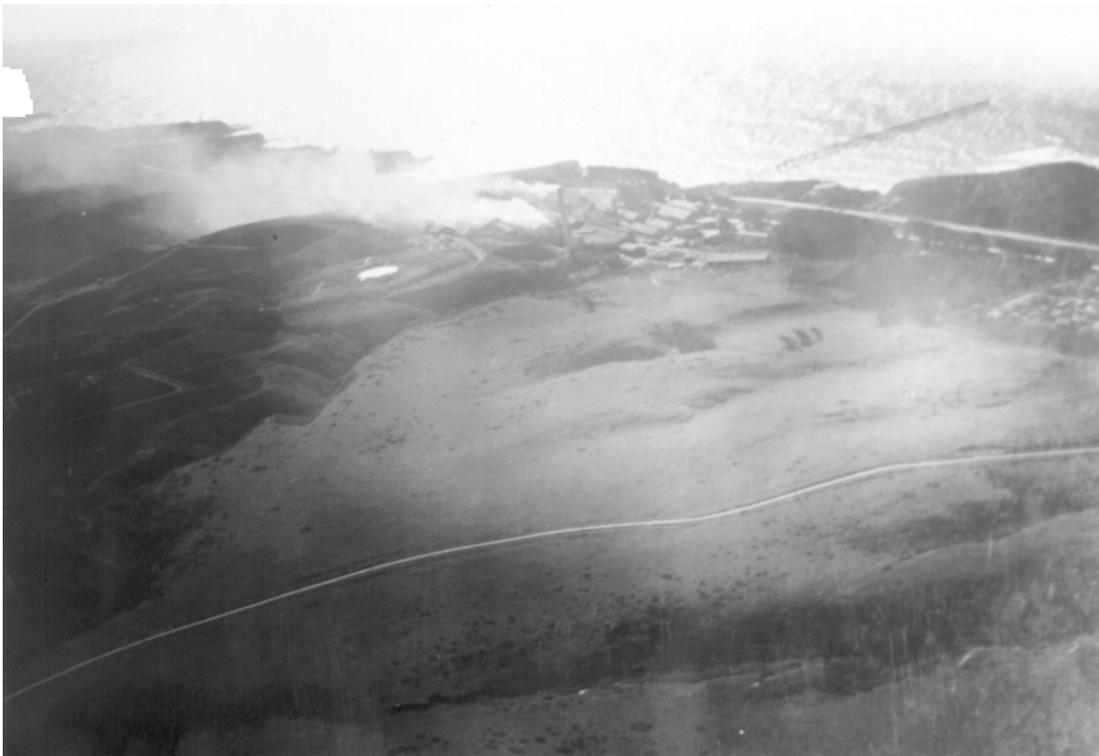
**Photo 1-10:** Cement plant, Pier and Dust, View to the Southwest, Date Unknown

In 1955, Davenport residents gathered in a public meeting to air their complaints about the dust. Many of those that testified brought exhibits to demonstrate just how pervasive the dust was, including a cross-section of lawn showing that the dust penetrated six inches into the earth. One auto mechanic brought a fifteen-pound bag of cement dust that he had collected in just one day while servicing the dust-covered automobiles of Davenport residents. Residents complained of being unable to get the family laundry clean, and one testified that they could not keep a television set because the dust always seeped into the cabinet and shorted it out (*Sentinel* 3/18/1955). Several dozen lawsuits were filed against the company following the meeting (see Photo 1-10).

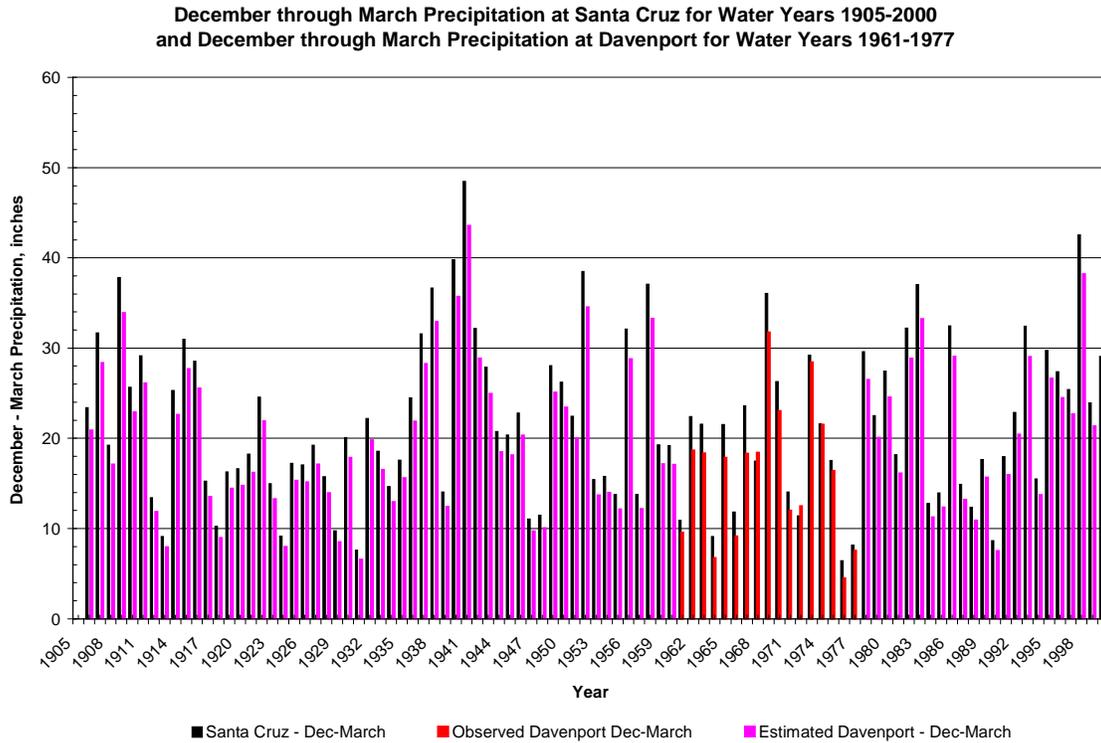
Note: The bar graph shows the December through March (winter) precipitation for Santa Cruz from 1905-2000. The precipitation observed at Davenport from 1961 to 1977 is also shown. Precipitation at Davenport for the periods 1905-1960 and 1978-2000 was estimated by linear regression with the Santa Cruz data.

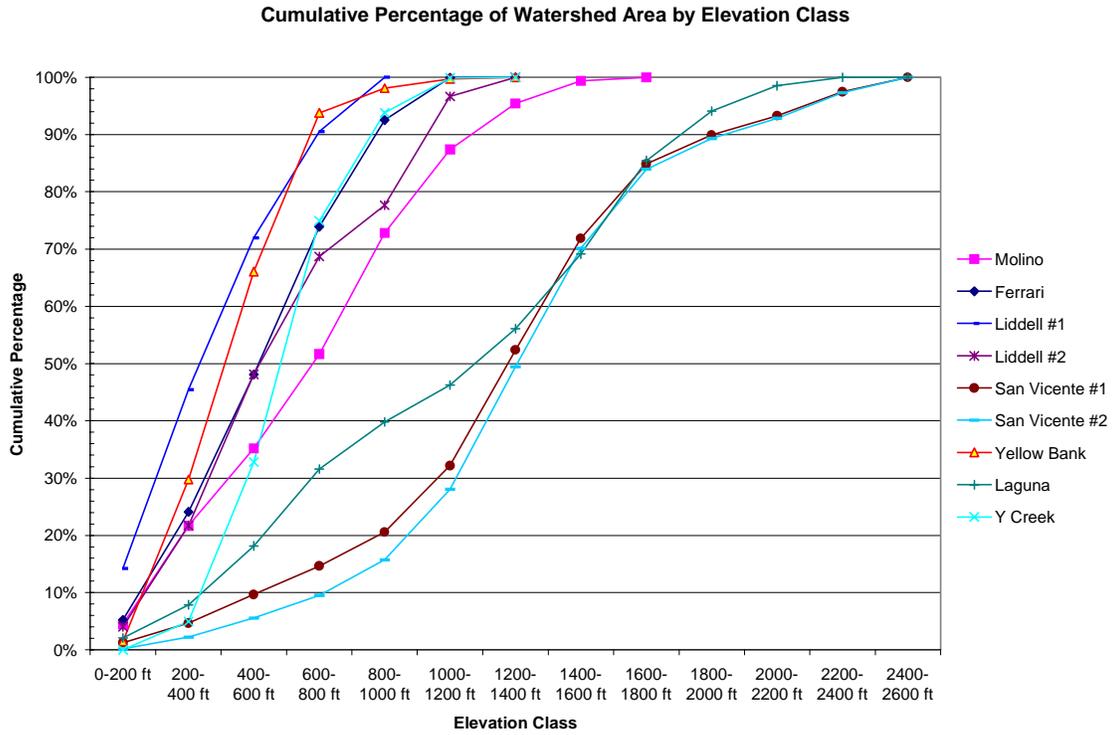
Note: The cumulative percentage of watershed area in each 200' elevation class.

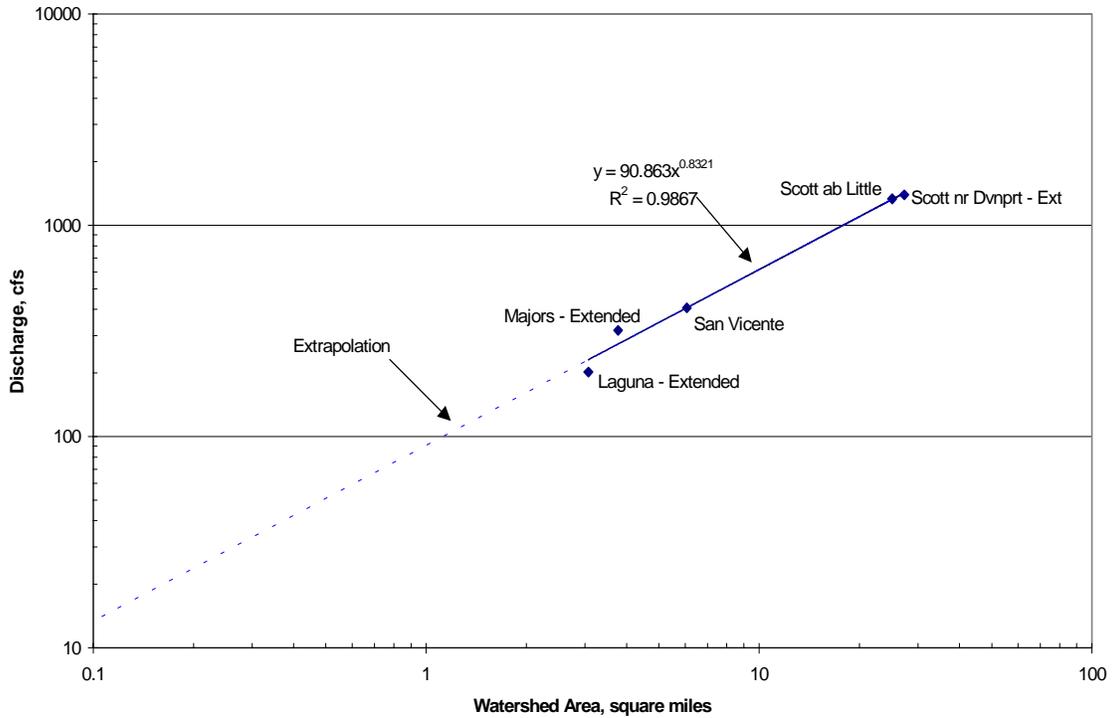
Note: Mean annual flood versus watershed area for 5 USGS stream gauging stations near Davenport. The annual flood series for Scotts Creek near Davenport was extended to 19 years by regression with the record for Scotts Creek above Little Creek. The annual flood series for Laguna and Majors Creek were extended by regression with the San Vicente gauge record.

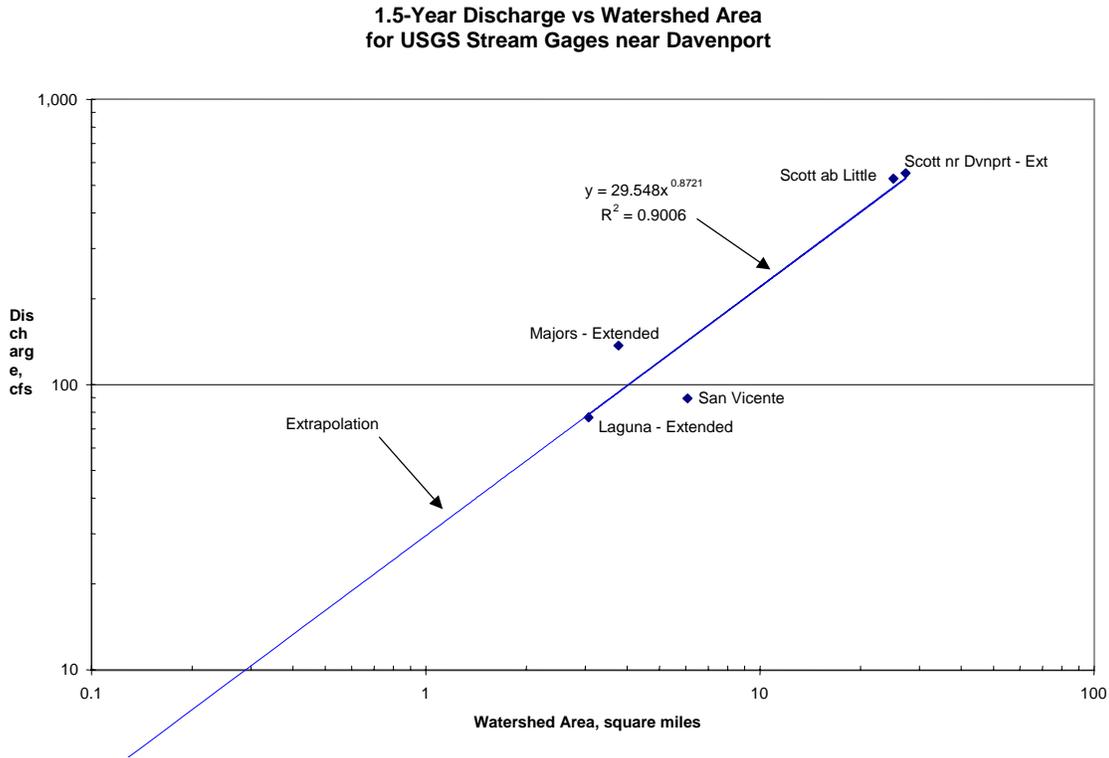
Note: Flood data from the five USGS stream gauging stations near Davenport was used to develop a regional relationship between the 1.5-year discharge and watershed area. The flood records for Laguna Creek and Majors Creek were extended by regression against the San Vicente flood record. The flood record for Scotts Creek near Davenport was extended by regression against the record from Scotts Creek above Little Creek.

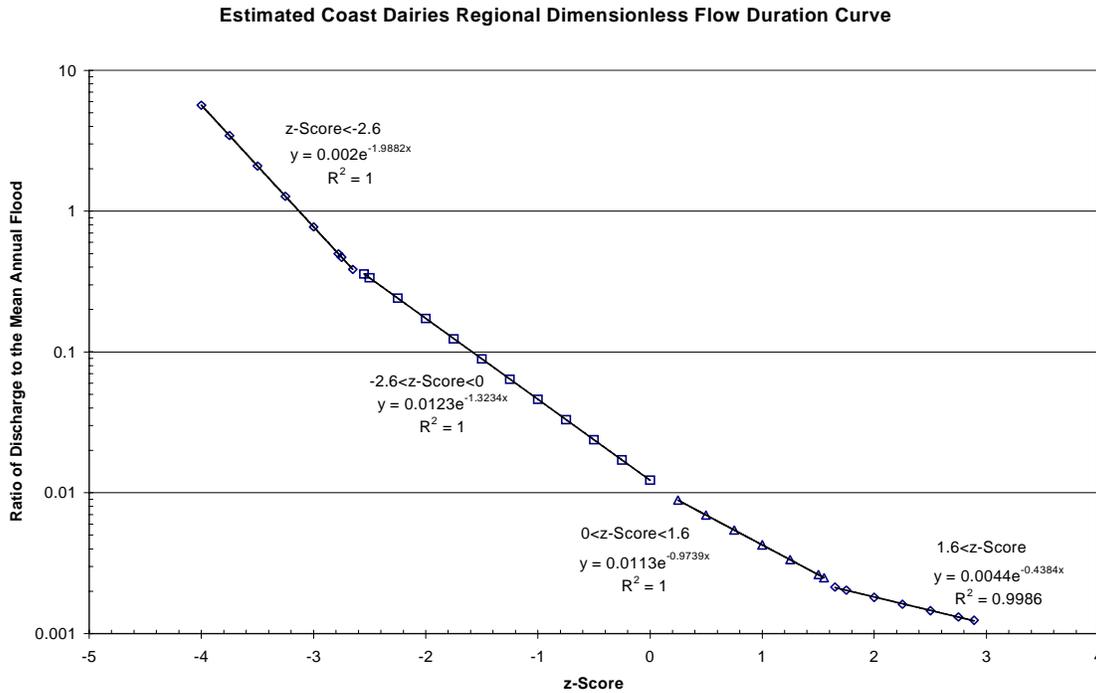
Note: The estimated regional flow duration curve for the Coast Dairies Property. The curve is the average of the data for the USGS stations on San Vicente and Laguna Creeks. A z-score of 0.0 indicates a 50 percent exceedence probability.

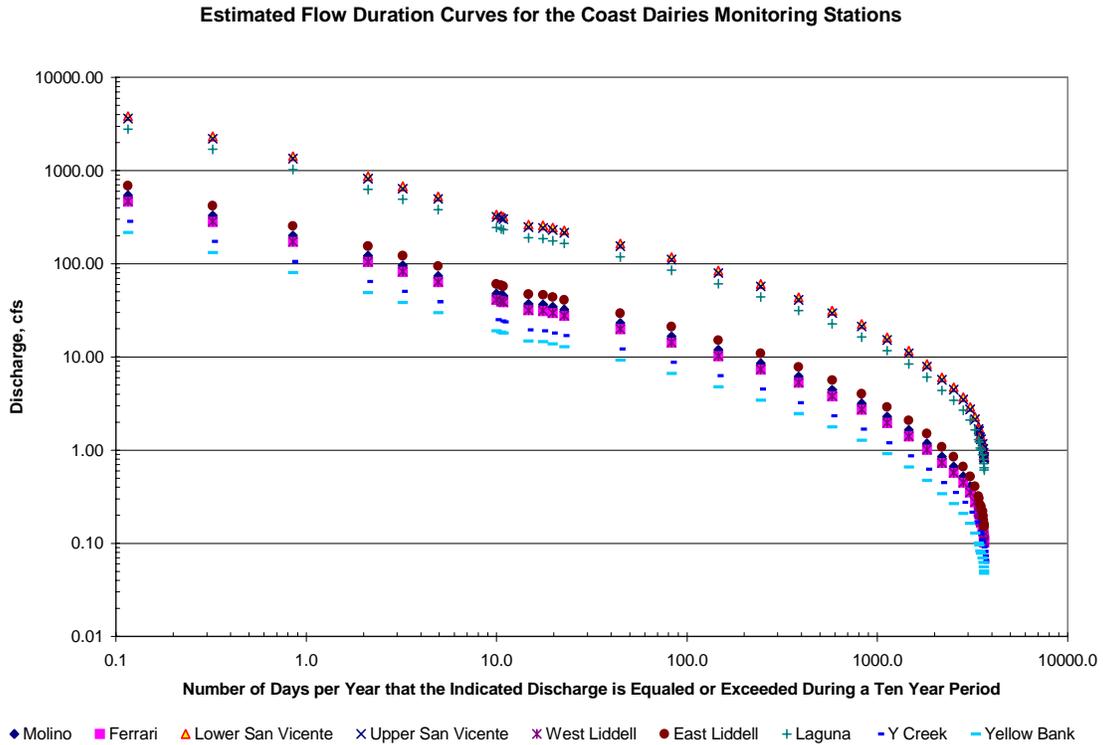
Note: Estimated flow duration curves for the nine Coast Dairies stream monitoring stations. The values on the x-axis have been converted from exceedence probability to the number of days during a *theoretical* ten year period that the indicated discharge is equaled or exceeded.

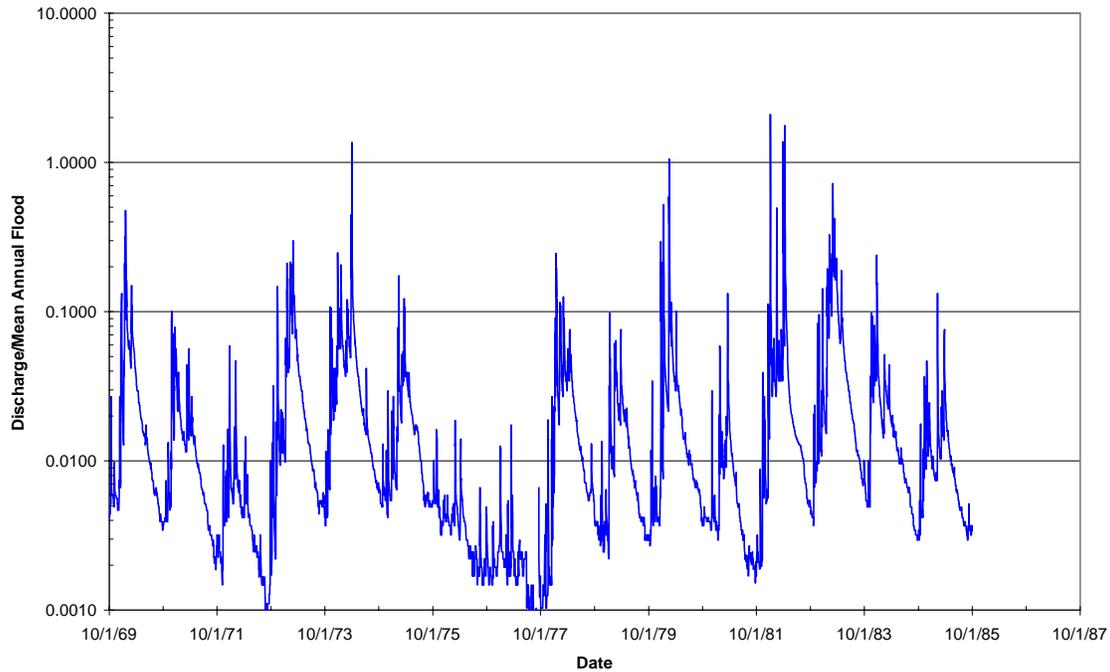
Relative Discharge for the USGS San Vicente Stream Gauge

Note: The relative discharge is the daily average discharge divided by the mean annual flood. The graph shows the relative discharge for the USGS stream gauge on San Vicente Creek. The mean annual flood for USGS gauge on San Vicente Creek is 407 cfs. The mean annual flood is calculated from the data collected during the 1937-1940, and 1969-1984 water years.

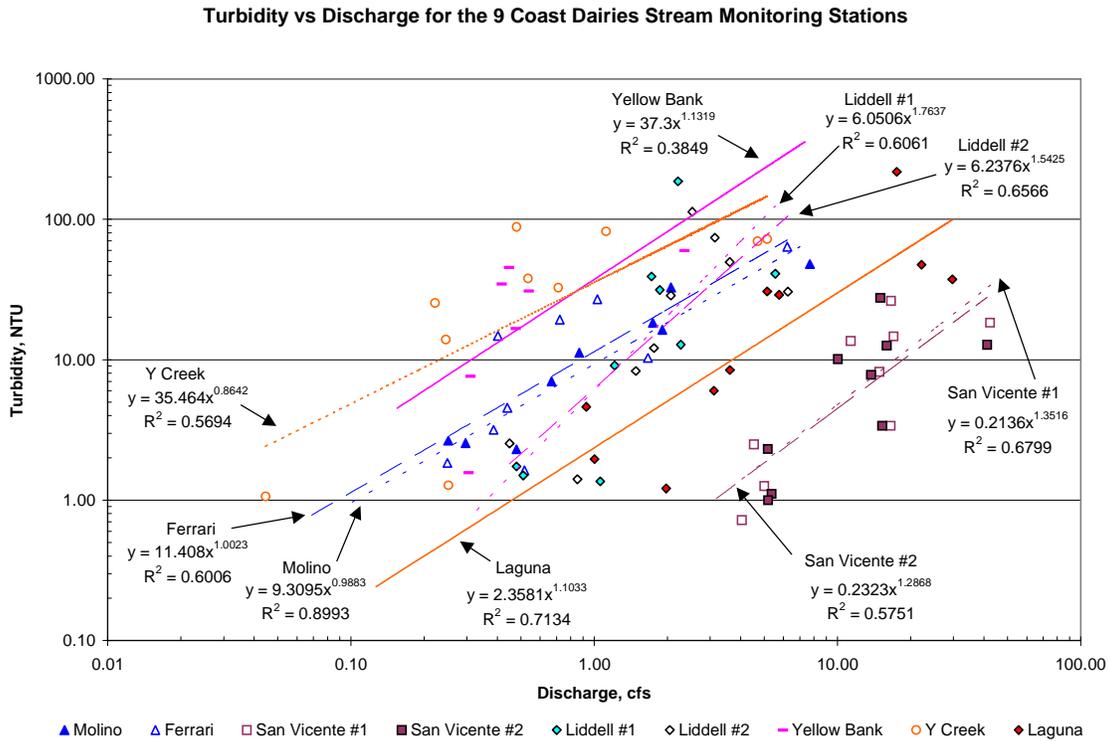
Note: The turbidity versus discharge relationship for the nine Coast Dairies stream monitoring stations. Six of the relationships are based on 9 observations. Seven turbidity samples were collected for Yellow Bank Creek. Ten turbidity measurements were made for Laguna Creek and Y Creek.

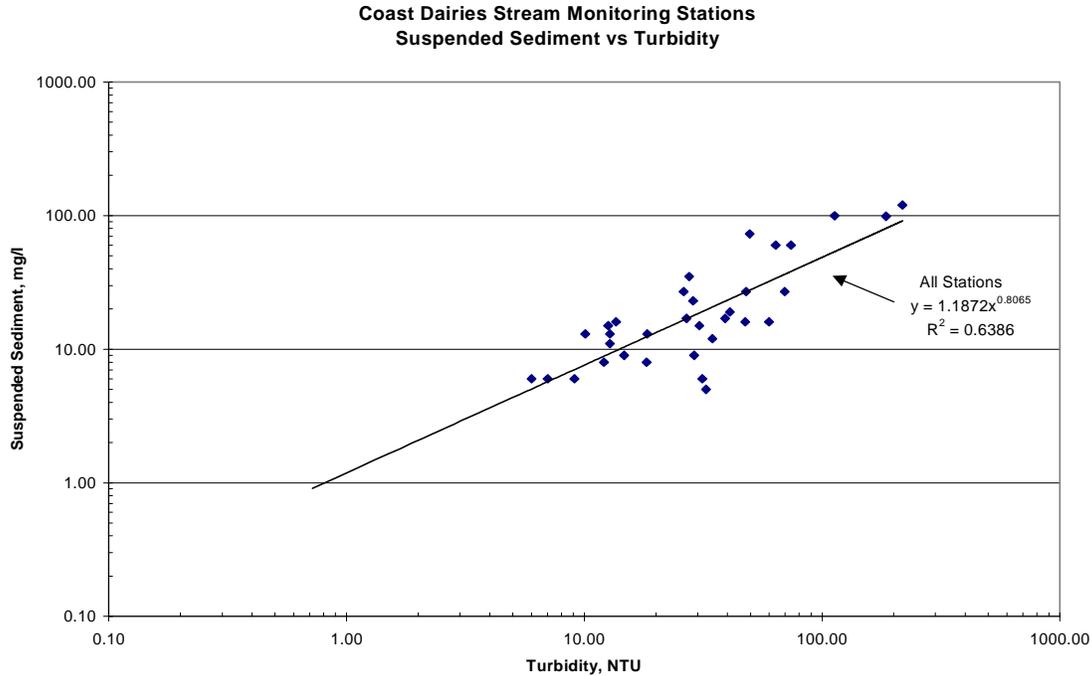
Note: A relationship between suspended sediment and turbidity was developed from the data collected at all of the monitoring stations. Turbidity explains about 64 percent of the variation in the suspended sediment value for the 33 available observations. The composite relationship for suspended sediment versus discharge explained about 6 percent of the observed variation in suspended sediment values.

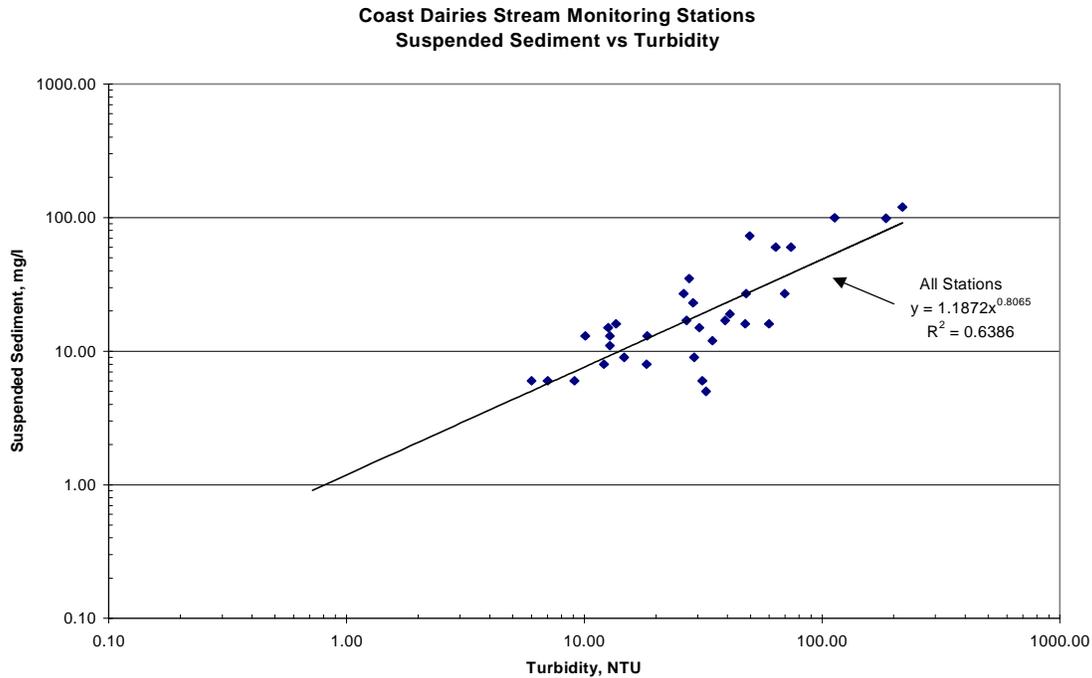
Note: A relationship between suspended sediment and turbidity was developed from the data collected at all of the monitoring stations. Turbidity explains about 64 percent of the variation in the suspended sediment value for the 33 available observations. The composite relationship for suspended sediment versus discharge explained about 6 percent of the observed variation in suspended sediment values.

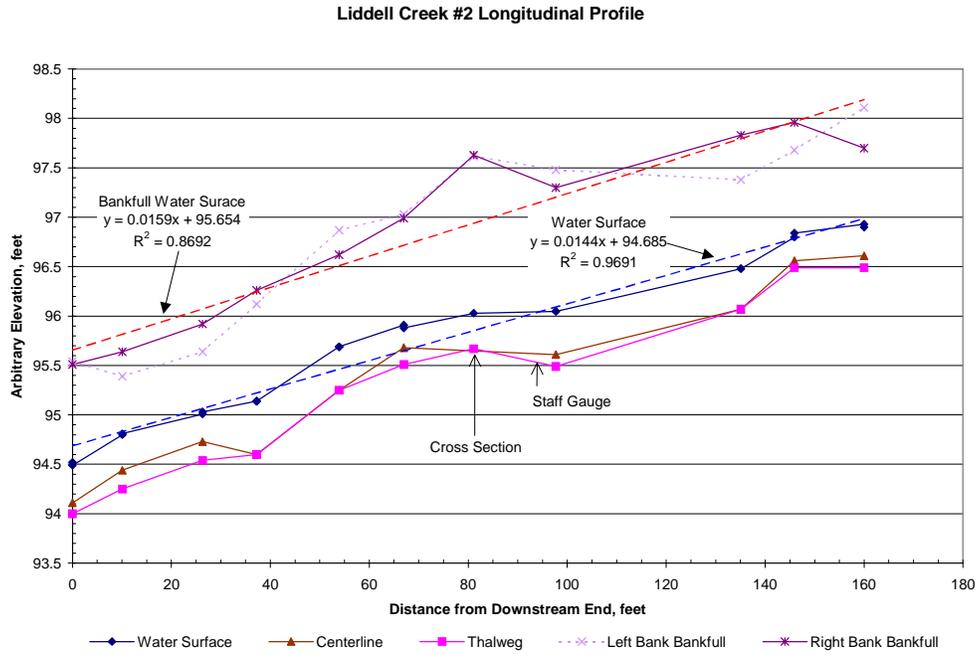
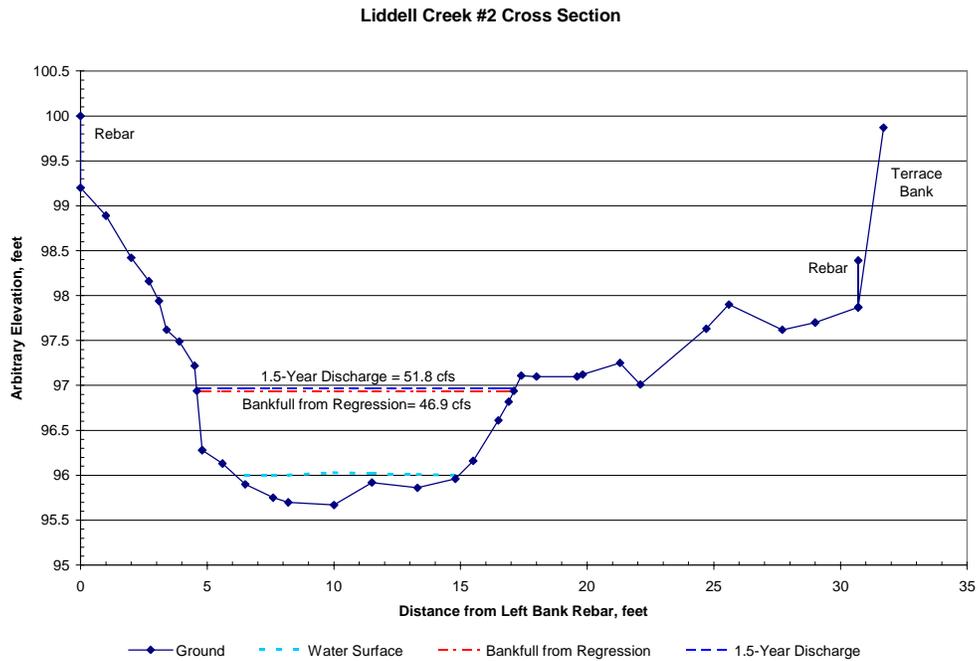
Note: The upper graph shows the longitudinal profile for Liddell Creek at station #2. The lower graph shows Liddell Creek in cross section at station #2.

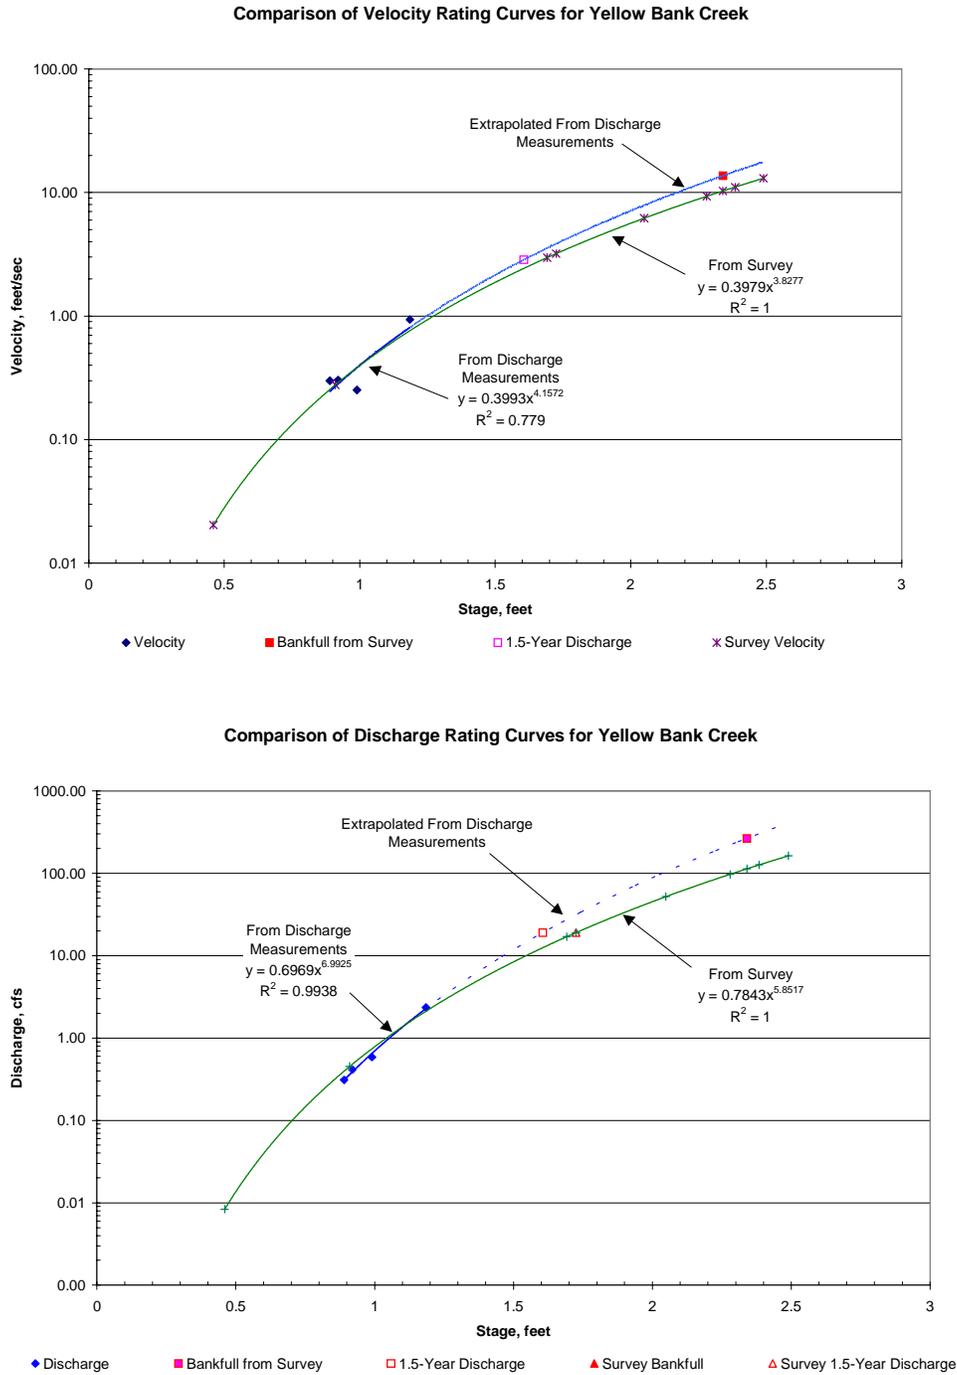
Note: The upper graph compares the velocity rating based on the discharge measurements and the velocity rating developed from the flow resistance equation and the survey for Yellow Bank Creek. The lower graph compares the discharge rating based only the discharge rating for Yellow Bank Creek.

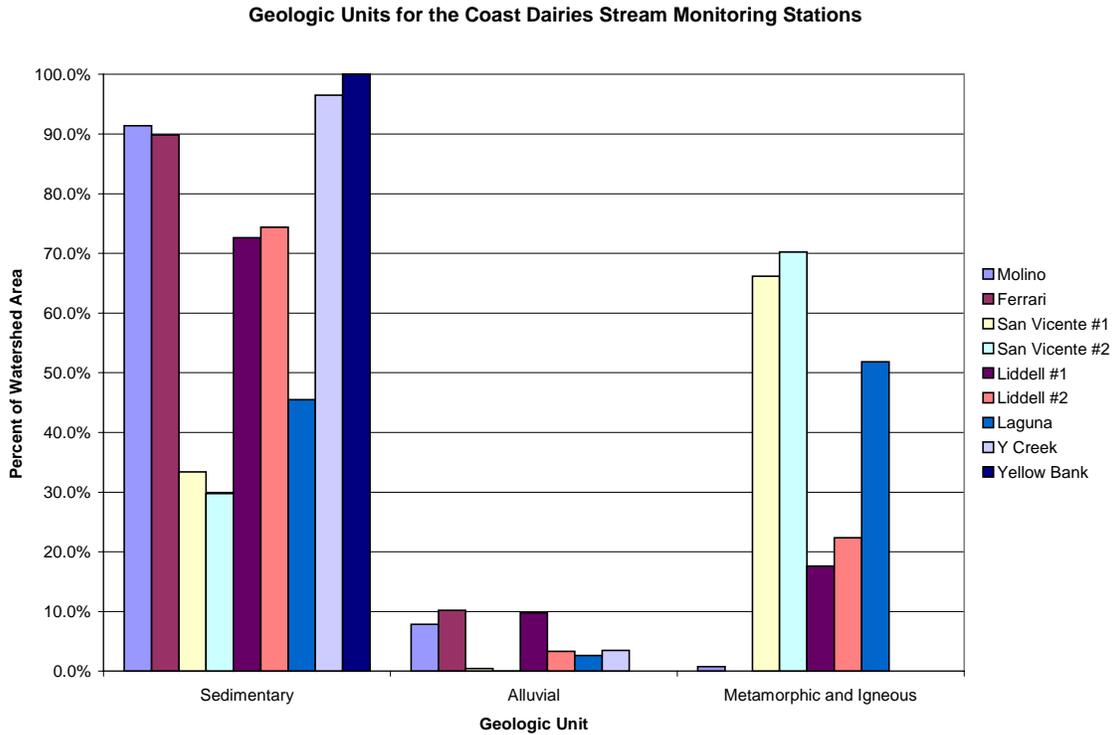
Note: The percentage of each monitoring watershed covered by sedimentary, alluvial or igneous and metamorphic rock is shown in the bar graph. Streams whose watershed geology is dominated by igneous metamorphic rocks are more likely to provide optimal salmonid habitat than streams whose watershed geology is dominated by sedimentary rock. Alluvial deposits can be composed of material derived from sedimentary, igneous or metamorphic rocks.

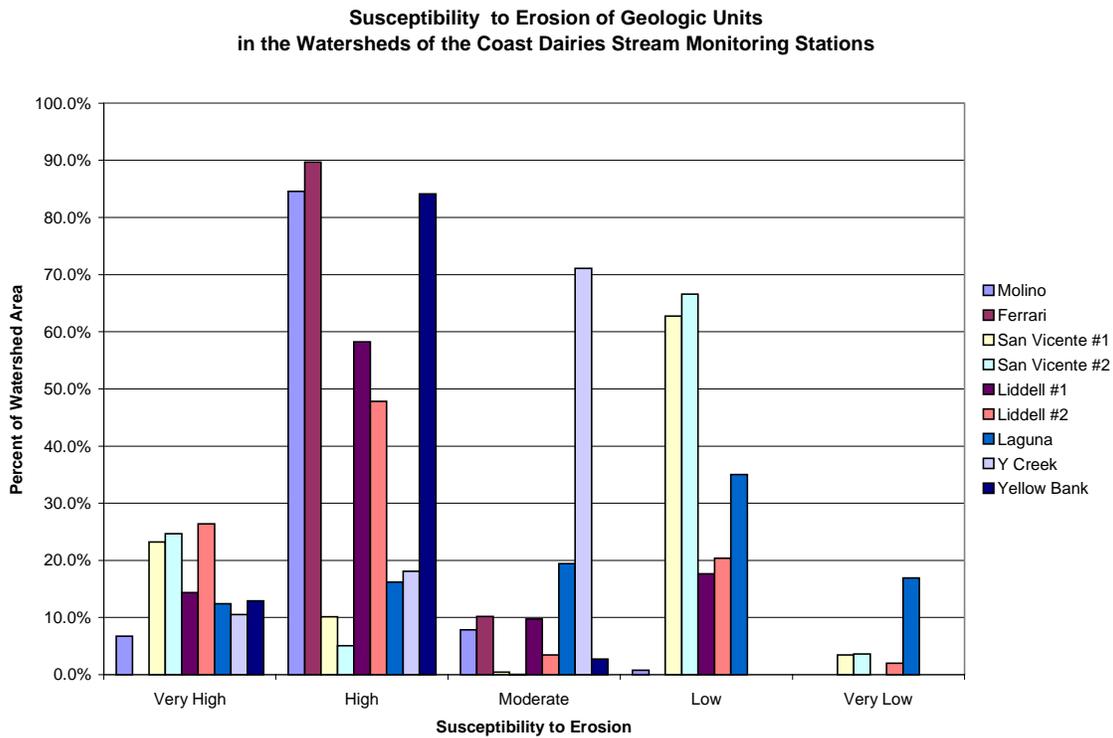
Note: Each geologic unit has been rated for its susceptibility to erosion. The graph shows the percentage of each watershed in each erosion susceptibility class.

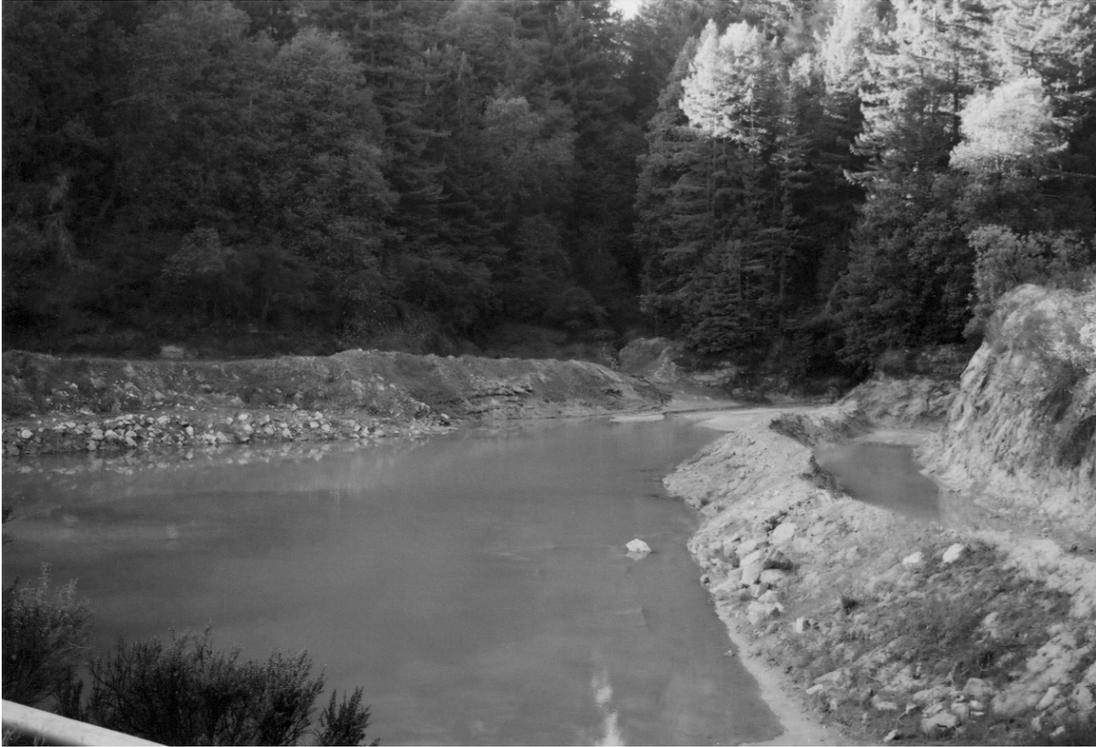
**Photo 5.4-9:** RMC Pacific Materials' Settlement Basin #3 on the Coast Dairies Property
